VIEWS FROM SUBJECT PROPERTY

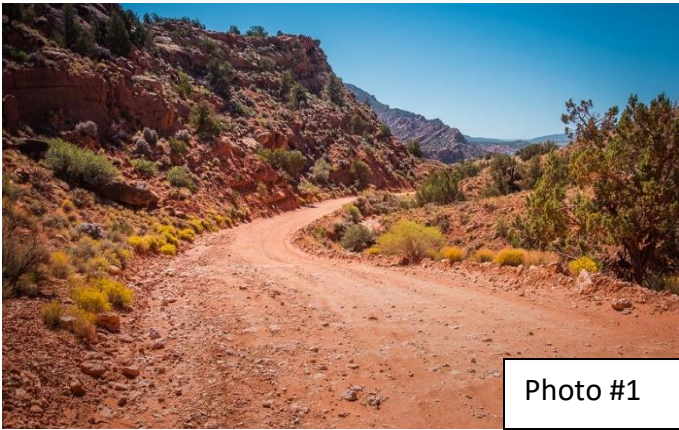
Photo #1 – Access road to subject property (2.6 miles from main county road)
